CWA COMPLIANCE EVALUATION INSPECTION REPORT
U.S. ENVIRONMENTAL PROTECTION AGENCY, REGION 5

Purpose:
Compliance Evaluation Sampling Inspection

Ex. 6 (Personal Privacy) Farms

Date of Inspection:
November 6, 2013

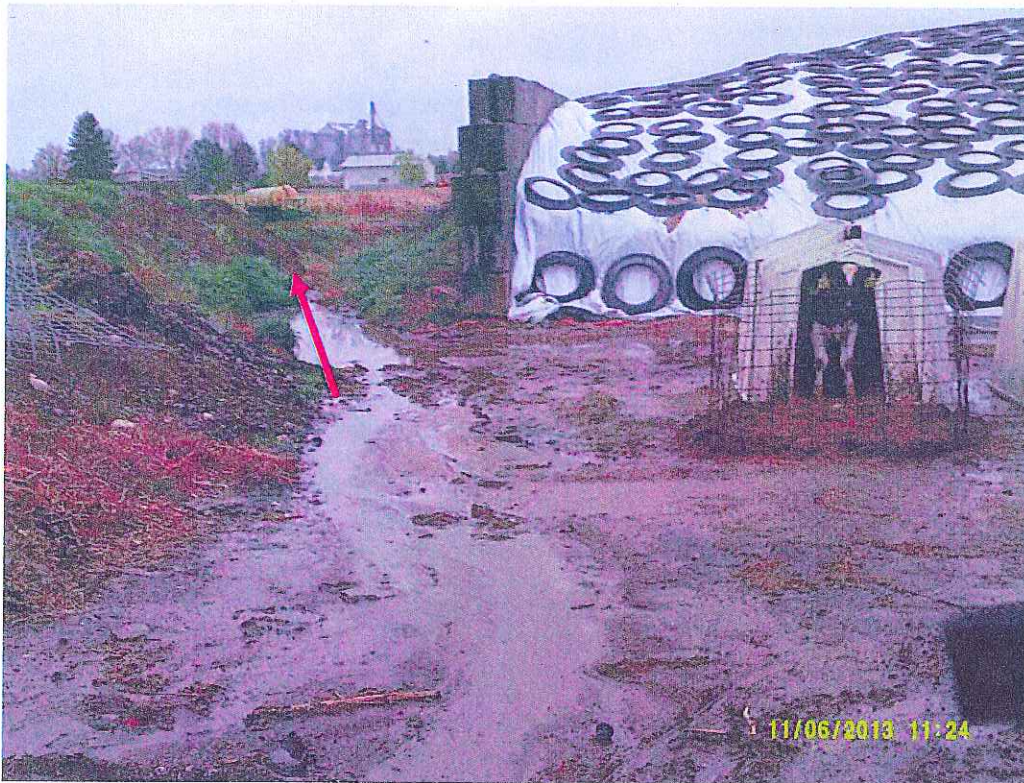
Then inspectors then walked back north to the north access road and walked east toward Building 1. The inspectors noted surface runoff flowing around the calf hutches located north of the feed bunker. Surface runoff was also seen flowing from around the calf hutches on the east side of Building 3. The inspectors also saw surface runoff flowing through the feed extending beyond the front edge of the feed bunker. The runoff seen flowing from around the two calf hutch areas and from around the front of the feed bunker was observed flowing to the north end of center ditch.

Photo DSCF0055: Surface runoff flowing around calf hutches and feed bunker flowing to center ditch.
Date/Time: 11/6/2013 11:24 A.M. Location: North end of center ditch. Facing: South

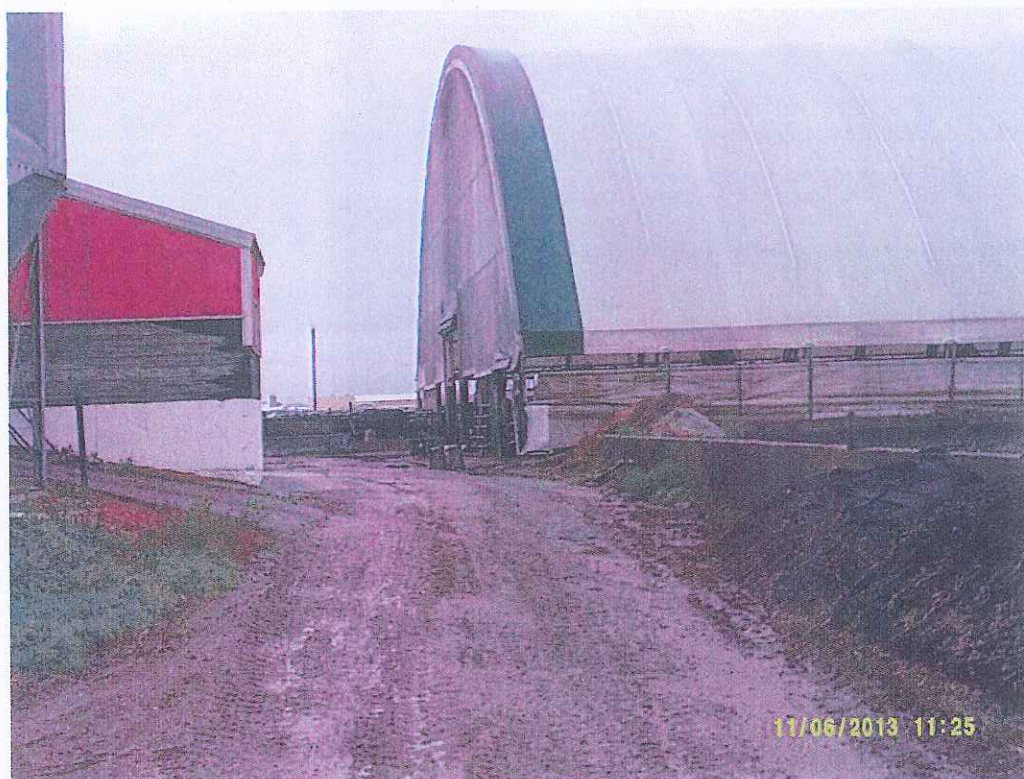
The inspectors continued east toward Building 1. The manure storage pit had earth mounded around the concrete walls. The pit was not overflowing at the time of the inspection. There appeared to be less than one foot of freeboard. There was either manure or soil noted on the top of the manure storage structure walls. The inspectors then returned to the beginning point of the inspection.

Photo DSCF0060: Northwest corner of the manure storage pit.

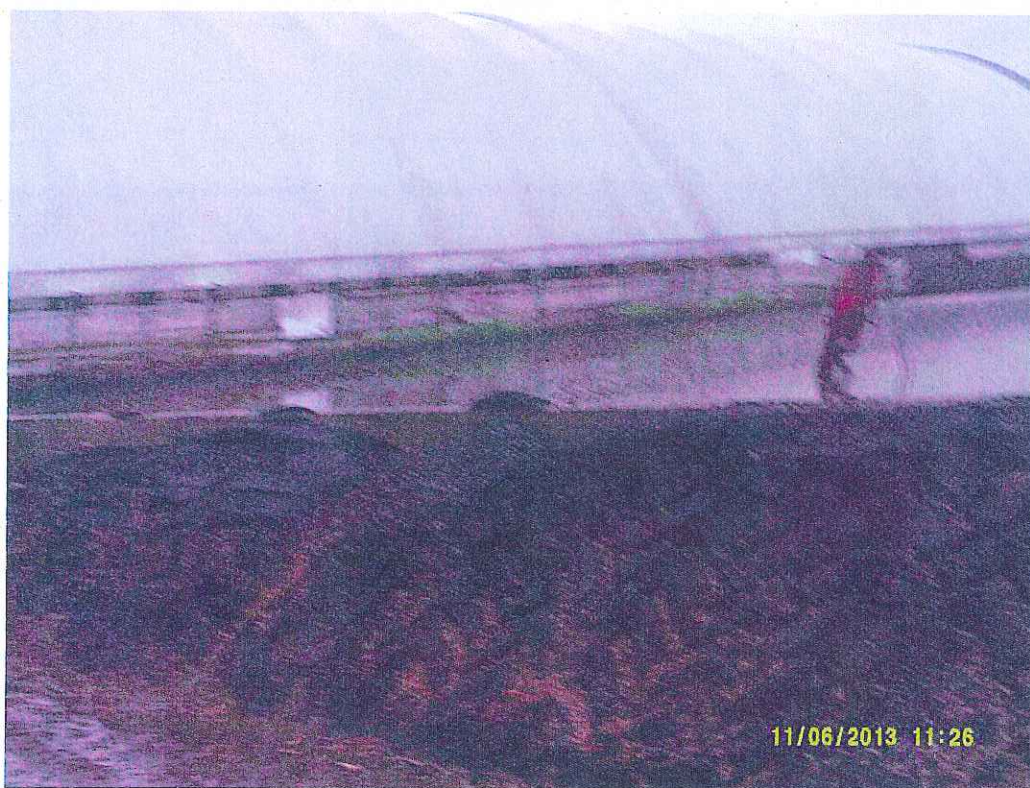
Photo DSCF0063: Levels within the Manure Storage Structure

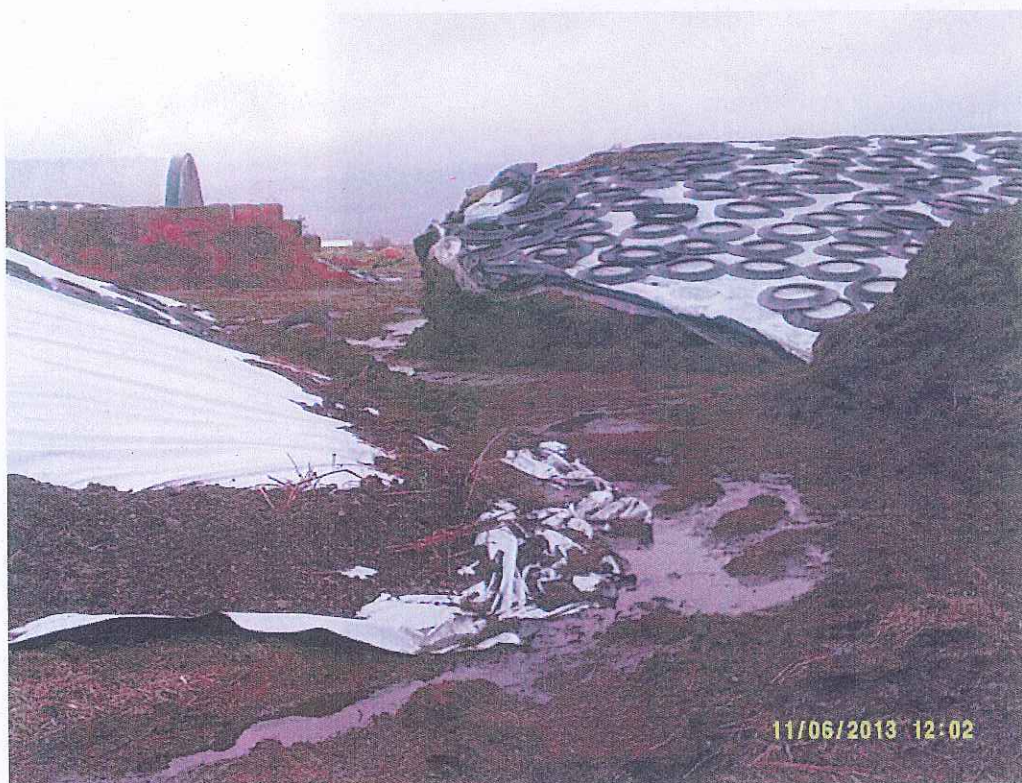
Photo DSCF0068: Flow of leachate and surface runoff from between covered feed mounds 1 and 2 west to unnamed intermittent tributary.

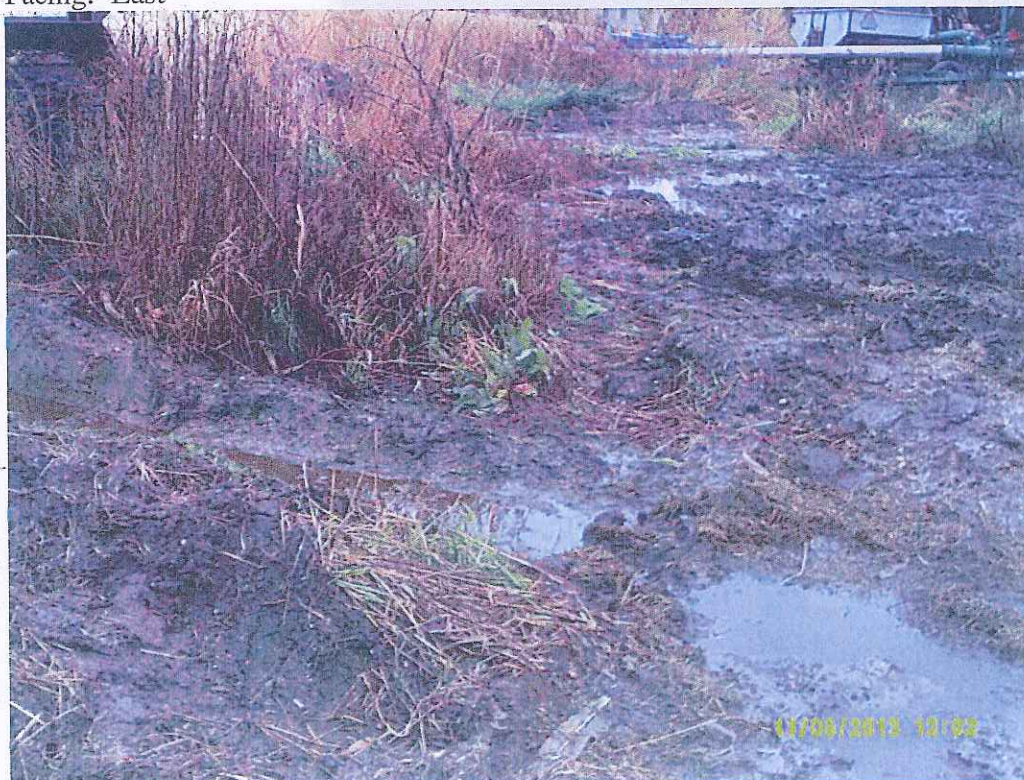
Photo DSCF0069: Flow of runoff through pathway 2 to unnamed intermittent tributary.

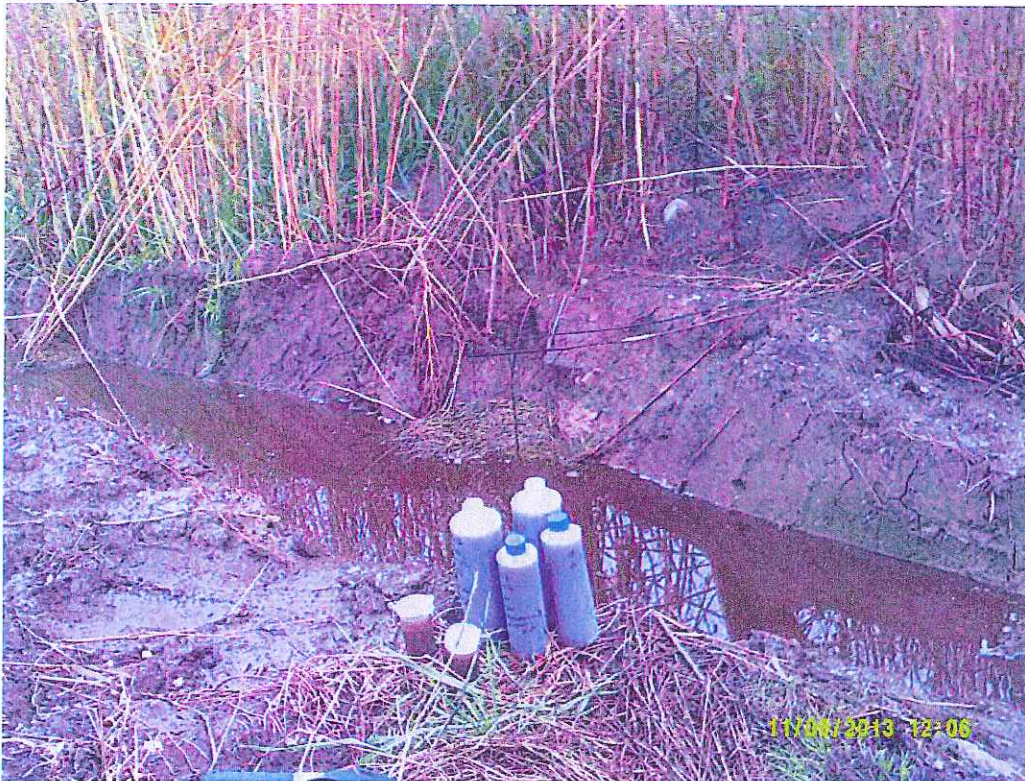
PhotoDSCF0070: Pathway 2 and sample S02.

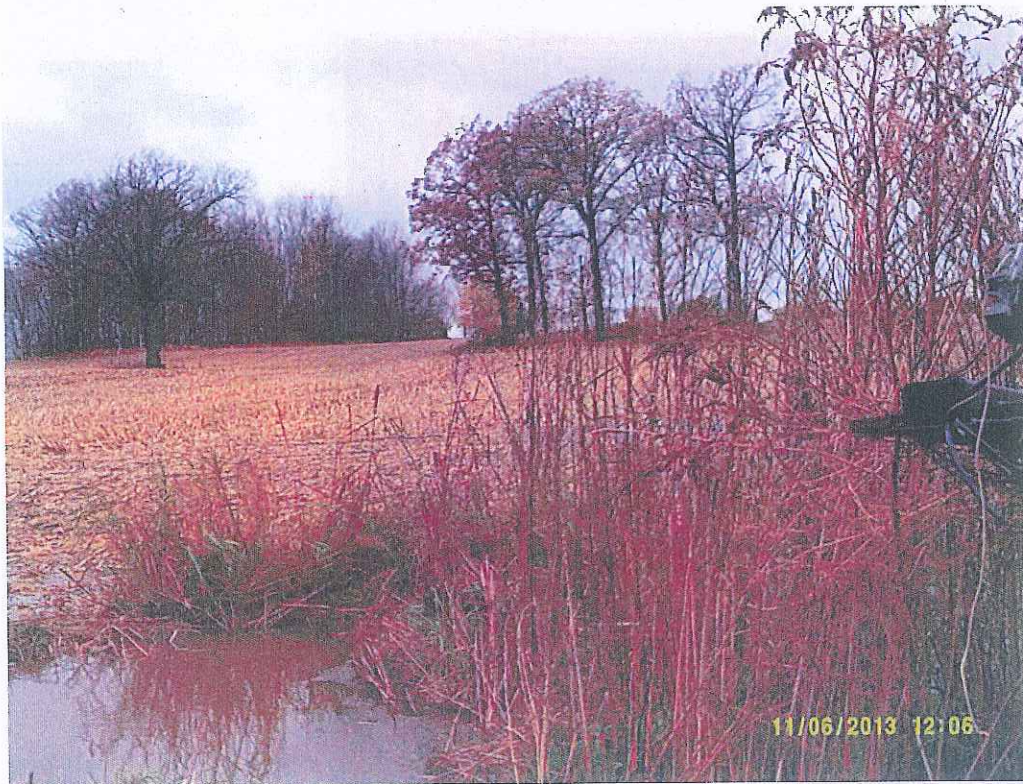
Photo DSCF0073: Pathway 2 flowing into intermittent unnamed tributary.

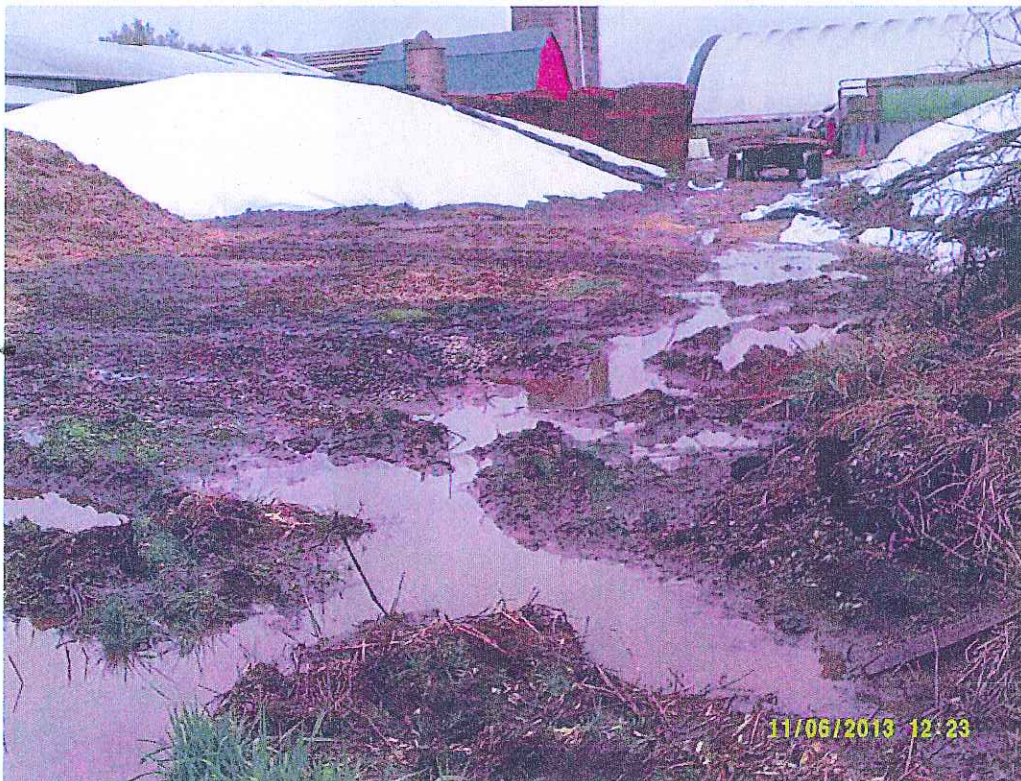
Photo DSCF0078: Flow of runoff, leachate, and feed debris to pathway 3.
